**Flood Control Project Maintenance
Levee Inspections**

Fall 2015 Levee Maintenance Deficiency Summary Report

Sacramento River Basin

Sacramento Maintenance Yard Sacramento Bypass

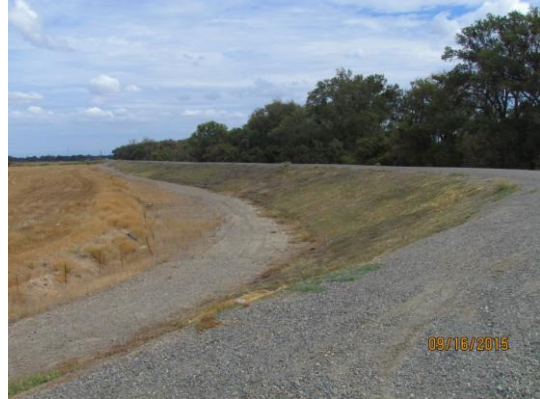
Photo 1 of 1 : FA_2015_ST0008_284_6_20150921_00002.jpg

LM Start	0.01	Rating **	A	Issue No.	6
LM End	1.73	Issue Type +	Ma	Location *	LS
Category	Earthen Levee			GPS Latitude/Longitude	
				Start	End
Item	Vegetation			38.607170 °	38.599512 °
				-121.560117 °	-121.590178 °
DWR ID	DWR_ST0008_01_f_2015_6				
Action/Comments					
Control annual grass and weeds on the levee slopes and easements. Inspector Comments: Vegetation on the slope has been maintained.

View of the vegetation on the landward side of the levee looking upstream. Photo taken at levee mile 1.73. Fall 2015.

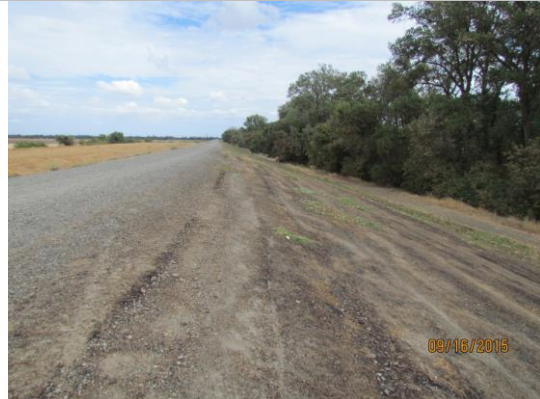
Photo 1 of 1 : FA_2015_ST0008_284_7_20150921_00003.jpg

LM Start	0.01	Rating **	A	Issue No.	7
LM End	1.73	Issue Type +	Ma	Location *	WS
Category	Earthen Levee			GPS Latitude/Longitude	
				Start	End
Item	Vegetation			38.607170 °	38.599512 °
				-121.560117 °	-121.590178 °
DWR ID	DWR_ST0008_01_f_2015_7				
Action/Comments					
Control annual grass and weeds on the levee slopes and easements. Inspector Comments: Vegetation has been burned and dragged.

View of the vegetation on the waterward side of the levee looking upstream. Photo taken at levee mile 1.73. Fall 2015.

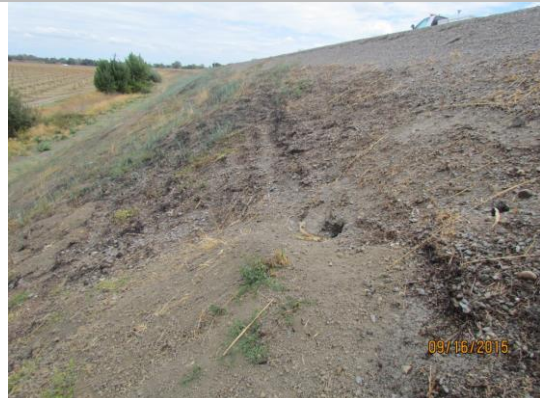
Photo 1 of 1 : FA_2015_ST0008_284_10_20150921_00007.jpg

LM Start	0.94	Rating **	M	Issue No.	10
LM End	0.94	Issue Type +	Ma	Location *	LS
Category	Earthen Levee			GPS Latitude/Longitude	
				Start	End
Item	Animal Control			38.602763 °	38.602763 °
				-121.576288 °	-121.576288 °
DWR ID	DWR_ST0008_01_f_2015_10				
Action/Comments					
No rodents visible, but rodent burrows visible; need to backfill and compact or grout burrows.

View of the rodent holes on the landward side of the levee looking upstream. Fall 2015.

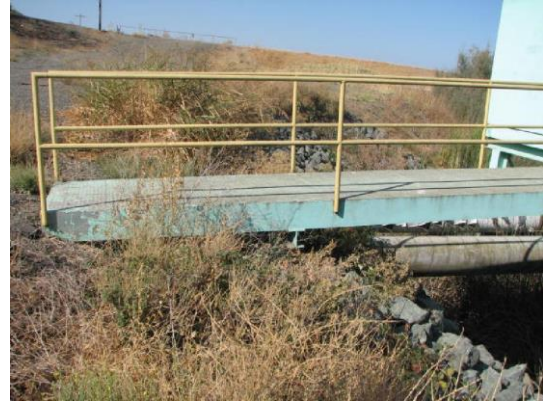
Photo 1 of 3 : UCIP_FA_2015_0277.jpg

Inspector Comments: FS_ID:44783
 DS_ID:19066
 EP_NO: 13616
 FS_HLM: 1.14
 Repair Type: Non-Urgent
 Crossing Status: Found
 UCIP Comments: After more investigation depressions are from water run off. erosion repair needed
 FIELD_STRUCT_DESC: 1 of 2. A agriculture drainage pumping system with 24-inch and 20-inch steel discharge pipelines through the north levee of the Sacramento Bypass. The pipe is 6.33 ft below the crown and a siphon breaker on the WS. Vertical GI pipe trash rack on inlet structure. Application no. 13616, 1995 (revised).
 FS Date: 04/28/2015

Landside view: walkway to the pump house.

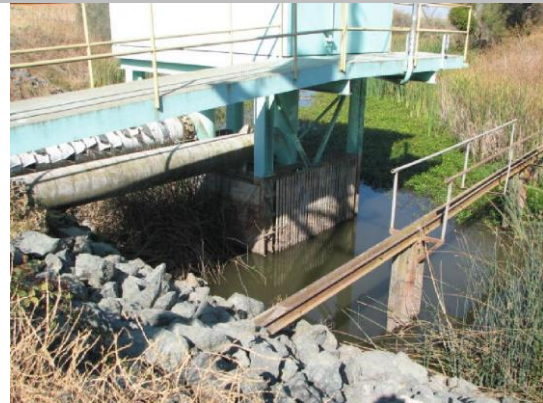
Photo 2 of 3 : UCIP_FA_2015_0278.jpg

Landside view: vertical GI pipes in inlet structure.

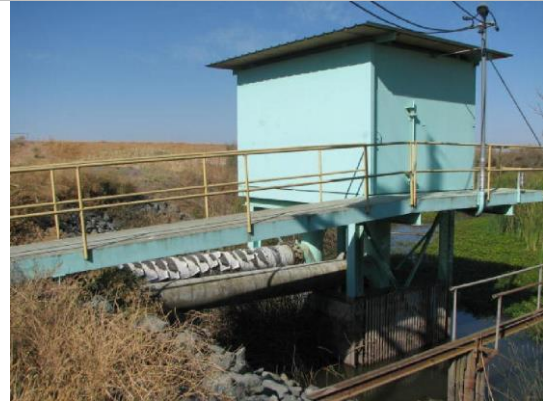
Photo 3 of 3 : UCIP_FA_2015_0279.jpg

LM Start	1.10	Rating **	M	Issue No.	11 (cont)
LM End	1.10	Issue Type +	En	Location *	LS
Category	Supplemental			GPS Latitude/Longitude	
				Start	End
Item	DWR UCIP Field Study			38.602180 °	38.602180 °
				-121.579130 °	-121.579130 °
DWR ID					
Action/Comments					
Inspector Comments: FS_ID:44783					
DS_ID:19066					
EP_NO: 13616					
FS_HLM: 1.14					
Repair Type: Non-Urgent					
Crossing Status: Found

Landside view: pumping plant overview

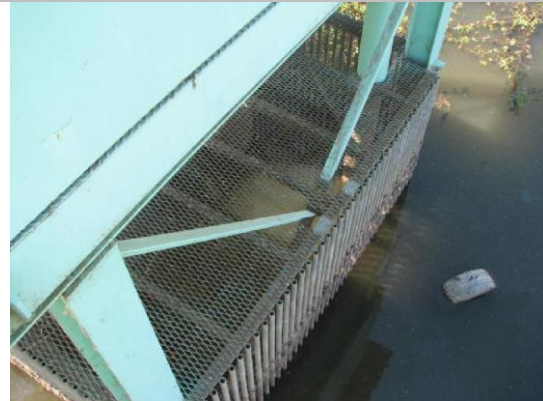
Photo 1 of 3 : UCIP_FA_2015_0310.jpg

LM Start	1.10	Rating **	M	Issue No.	12
LM End	1.10	Issue Type +	En	Location *	LS
Category	Supplemental			GPS Latitude/Longitude	
				Start	End
Item	DWR UCIP Field Study			38.602128 °	38.602128 °
				-121.579150 °	-121.579150 °
DWR ID					
Action/Comments					
Inspector Comments: FS_ID:44784 DS_ID:19079 EP_NO: 13616 FS_HLM: 1.142 Repair Type: Non-Urgent Crossing Status: Found UCIP Comments: Horizontal Air vent on waterside slope. Green vegetation and depressions also found on waterside slope. FIELD_STRUCT_DESC: 2 of 2. A agricultural drainage pumping system with 24-inch and 20-inch steel discharge pipelines through the north levee of the Sacramento Bypass. The pipe is 6.33 ft below the crown and a siphon breaker on the WS. Vertical GI pipe trash rack on inlet structure. Application no. 13616, 1995 (revised). FS Date: 04/28/2015

Landside view: vertical GI pipe trash rack in inlet structure.

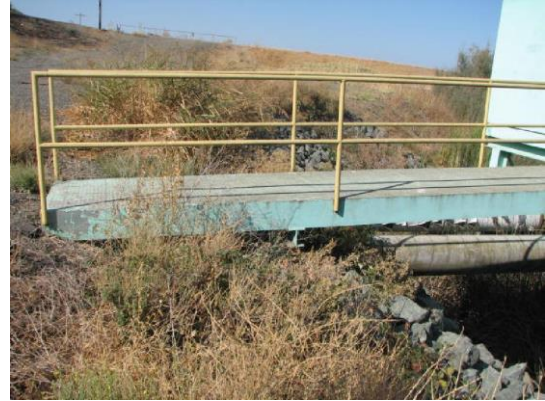
Photo 2 of 3 : UCIP_FA_2015_0311.jpg

LM Start	1.10	Rating **	M	Issue No.	12 (cont)	
LM End	1.10	Issue Type +	En	Location *	LS	
Category	Supplemental			GPS Latitude/Longitude		
				Start	End	
Item	DWR UCIP Field Study			38.602128 °	38.602128 °	
				-121.579150 °	-121.579150 °	
DWR ID						
Action/Comments						
Inspector Comments: FS_ID:44784 DS_ID:19079 EP_NO: 13616 FS_HLM: 1.142 Repair Type: Non-Urgent Crossing Status: Found UCIP Comments: Horizontal Air vent on waterside slope. Green vegetation and depressions also found on waterside slope. FIELD_STRUCT_DESC: 2 of 2. A agricultural drainage pumping system with 24-inch and 20-inch steel discharge pipelines through the north levee of the Sacramento Bypass. The pipe is 6.33 ft below the crown and a siphon breaker on the WS. Vertical GI pipe trash rack on inlet structure. Application no. 13616, 1995 (revised). FS Date: 04/28/2015

Landside view: walkway to the pumping plant

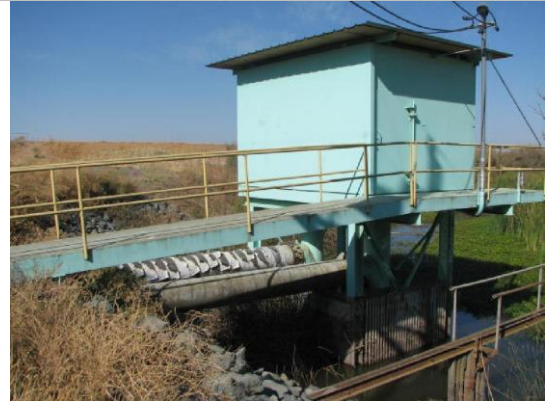
Photo 3 of 3 : UCIP_FA_2015_0312.jpg

Landside view: overview of pumping plant

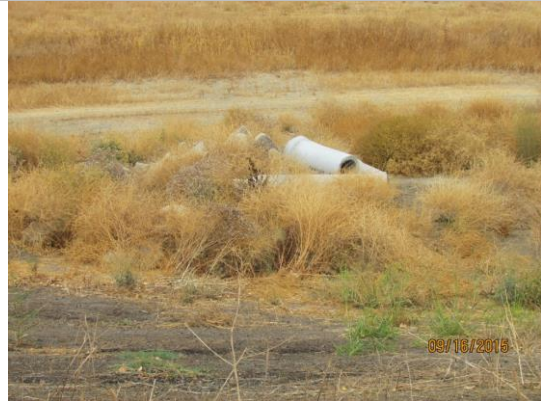
Photo 1 of 2 : FA_2015_ST0008_284_9_20150921_00006.jpg

LM Start	1.26	Rating **	M	Issue No.	9
LM End	1.26	Issue Type +	En	Location *	LS
Category	Earthen Levee			GPS Latitude/Longitude	
				Start	End
Item	Encroachments			38.601398 °	38.601398 °
				-121.581923 °	-121.581923 °
DWR ID	DWR_ST0008_01_f_2015_9				
Action/Comments					
Debris

The concrete debris is on the landward side of the levee. Fall 2015.

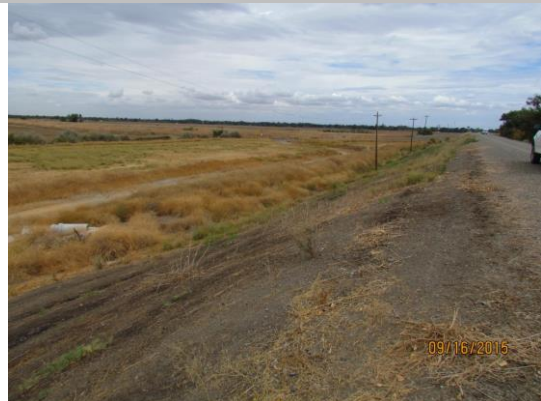
Photo 2 of 2 : FA_2015_ST0008_284_9_20150921_00005.jpg

Perspective view of the debris on the landward side of the levee looking upstream. Fall 2015.

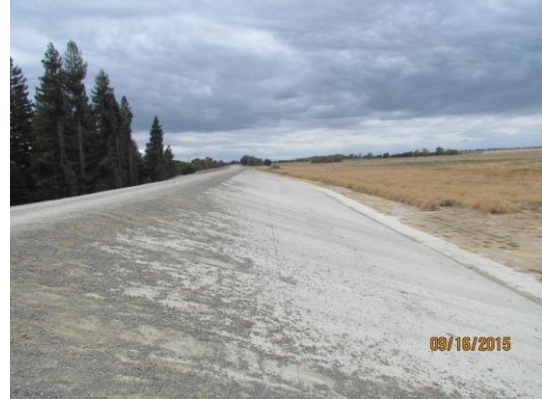
Photo 1 of 1 : FA_2015_ST0008_285_3_20150921_00004.jpg

LM Start	0.01	Rating **	A	Issue No.	3
LM End	1.10	Issue Type +	Ma	Location *	WS
Category	Earthen Levee			GPS Latitude/Longitude	
				Start	End
Item	Vegetation			38.602735 °	38.597894 °
				-121.555753 °	-121.574759 °
DWR ID	DWR_ST0008_02_f _ 2015_3				
Action/Comments					
Control annual grass and weeds on the levee slopes and easements. Inspector Comments: The vegetation has been mowed and burned and there is no visibility obstruction.

Looking at the vegetation on the waterward side of the levee looking downstream. Fall 2015.

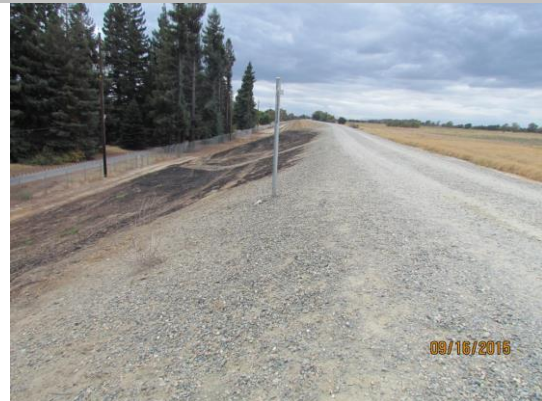
Photo 1 of 1 : FA_2015_ST0008_285_2_20150921_00003.jpg

LM Start	0.01	Rating **	A	Issue No.	2
LM End	1.78	Issue Type +	Ma	Location *	LS
Category	Earthen Levee			GPS Latitude/Longitude	
				Start	End
Item	Vegetation			38.602735 °	38.594626 °
				-121.555753 °	-121.586689 °
DWR ID	DWR_ST0008_02_f_2015_2				
Action/Comments					
Control annual grass and weeds on the levee slopes and easements. Inspector Comments: The slope has been burned and there is no obstruction to visibility.

View of the vegetation on the landward side of the levee looking downstream. Fall 2015.
